Contact Fatigue Analysis of Gears

Abstract: Contact fatigue tests are performed on gears. The pitting evolution of tooth surfaces is monitored by optical microscopy during the test. Wear status of gears is tracked via extracting wear debris from lubricant oil and analyzing debris quantity. After testing, gear teeth are sectioned and inspected under an electron microscope to characterize surface contact features.

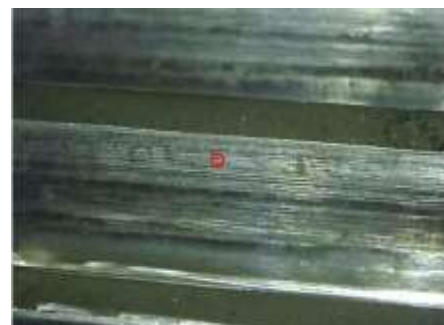
(a) Tooth surface morphology at 18h

Figure. 1 The tooth surface morphology at different moments observed by microscope

A digital microscope was used to measure the single-tooth pitting area ratio of the test gears. Ferrography was adopted to separate metallic wear particles from lubricating oil for gear wear prediction. The gears were rotated to locate the tooth with the most severe surface damage for image capture. The tooth surface morphologies at different operating durations are presented in Figure 1. As shown in Figure 1(a), after 18 hours of operation, the gear tooth surfaces underwent initial running-in with slight wear, and tiny pitting pits were observed. Initial pitting inevitably occurs at the early meshing stage due to differences in surface roughness and subsurface non-metallic inclusions. Such pitting generally does not propagate and causes minor damage to gears. Figure 1(b) shows that after 70 hours of operation, individual pitting pits appeared on the tooth surfaces, which were larger than the initial pits yet showed no sign of propagation. This phenomenon is attributed to inherent material defects that reduce the fatigue resistance of the local material around the pits. After 200 hours of operation (Figure 1(c)), the number of pitting pits increased, dominated by micropitting. These tiny pits clustered together and tended to expand further. At 213 hours of operation, the gear failed due to contact fatigue (Figure 1(d)). The scattered pits merged into continuous areas, and a grey line formed on the contact surface, commonly known as a grey spot. Since individual micropits are too small to be identified separately, the aggregation of numerous micropits results in the formation of grey spots.

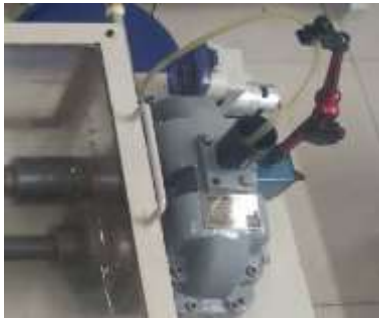
Figure. 2 Gear box lubricating oil circulation device

The quantity of wear particles in lubricant serves as a key indicator for evaluating gear wear. In this test, circulating oil injection lubrication was adopted. An oil pump was mounted on the test gearbox to keep the lubricant circulating, so that wear particles were distributed as evenly as possible in the oil. The oil circulation device is shown in Figure 2.

The oil pump remained operational throughout the test to sustain continuous lubricant circulation inside the gearbox. In this way, the collected oil samples could accurately reflect the overall distribution of wear particles and minimize sampling errors.

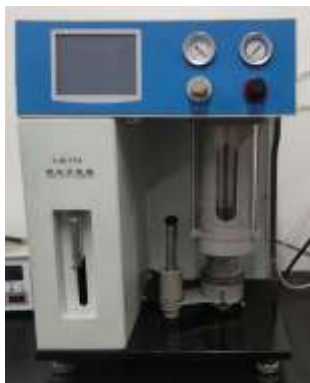
Figure. 3 Particle counter

The collected lubricant samples were tested with a YJS-170 particle counter (see Figure 3) to measure the size and quantity of wear particles. By analyzing samples taken at different time points, the contact condition and wear degree of gears during operation can be determined.
